Manhole Inspection Summary

Manhole # S35SS1027MH

Location Address: **4501 UNDERWOOD RD**

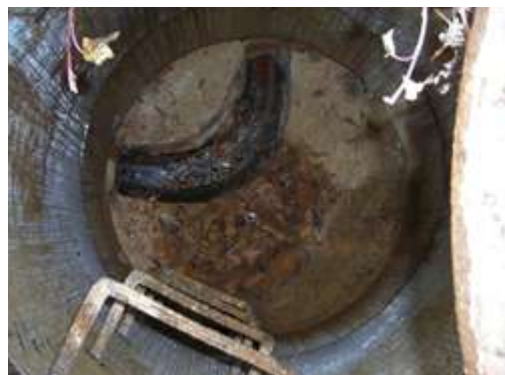
Top View

Corbel and Barrel infiltration. Bench debris.

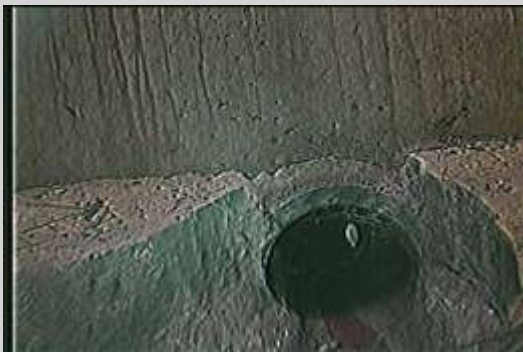
8 in. Circular Gravity Sewer Pipe Out @ 12 O'Clock

Infiltration: **Evidence** Pipe Seal Cond: **Unknown**

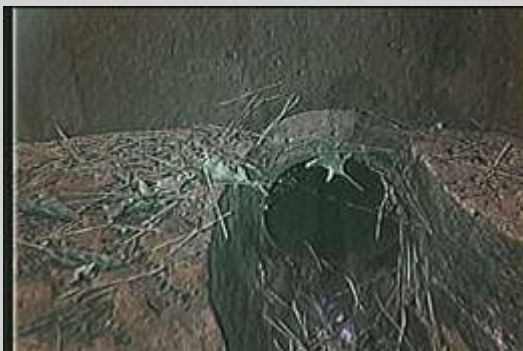
8 in. Circular Gravity Sewer Pipe In @ 9 O'Clock

Infiltration: **Evidence** Pipe Seal Cond: **Unknown**
